Utilization of Instrumentation Data for Averting a Potential Support Failure in a Deep Excavation Project

Arushi BHALLA¹, Prateek MEHROTRA²

Keywords: deep excavation, deformation monitoring, risk mitigation

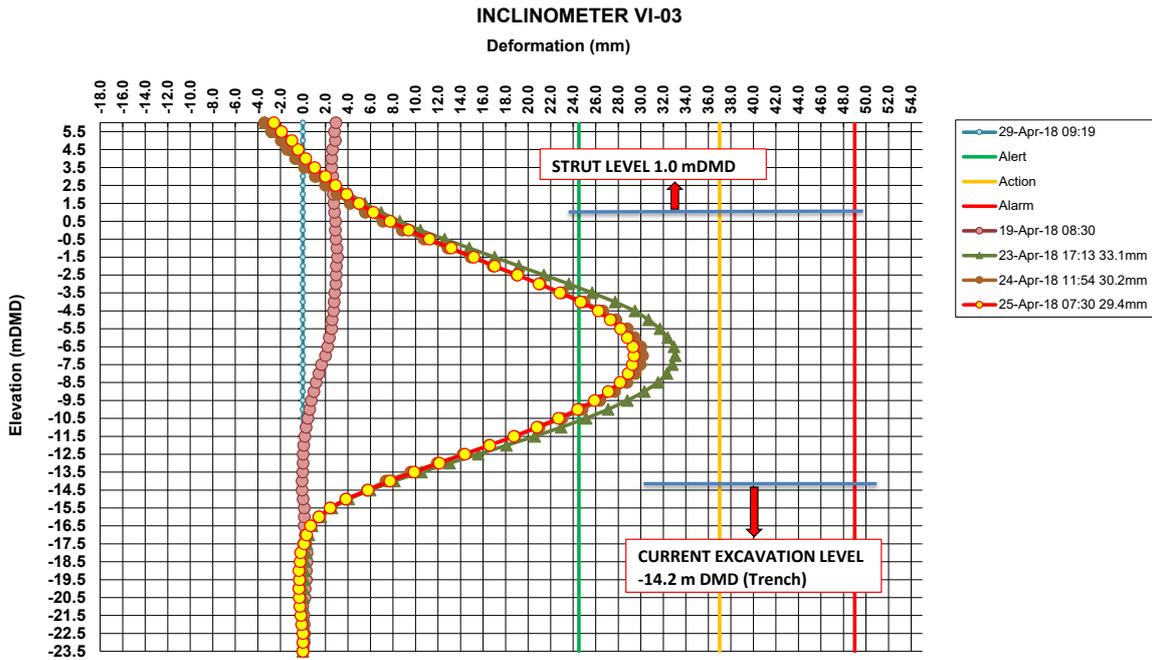
During the excavation period from April 19 to April 24, 2018, the recorded deflections in the inclinometer VI-03 showed sudden "jumps" up to 33 mm, as shown in Figure 3 below.

Figure 3: Inclinometer VI-03 data showing D-wall movement from April 19-24, 2018.

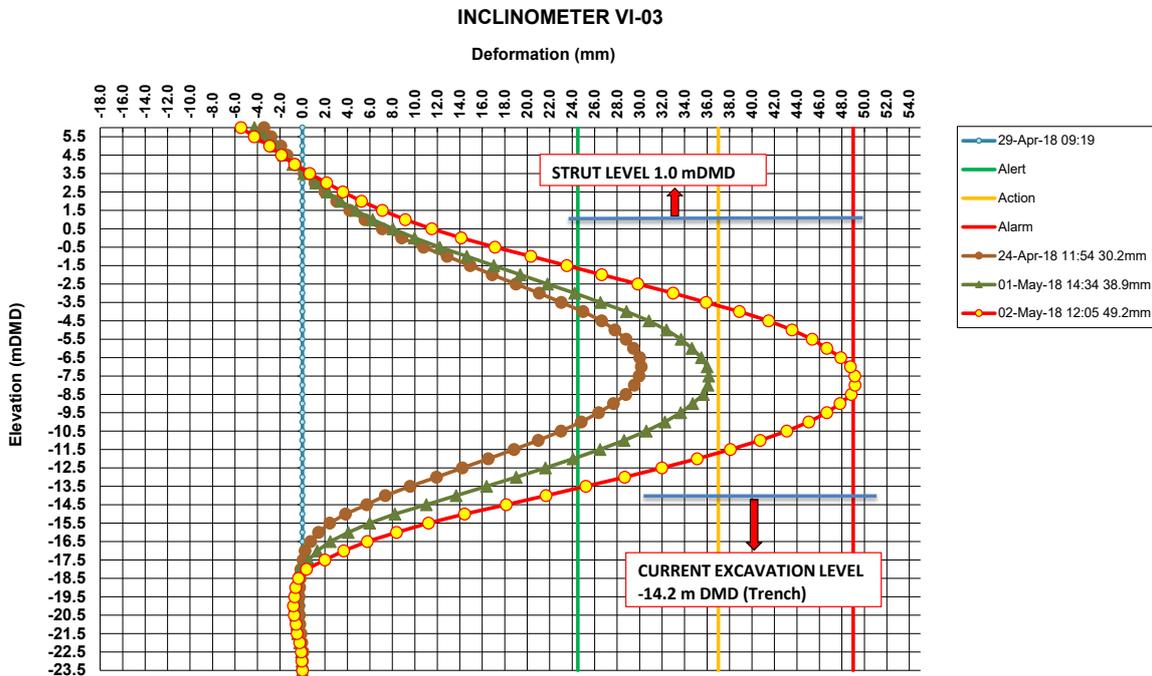
On May 1, 2018, the dewatering well ADW # 01 (location shown in Figure 2 above) was damaged by the nearby works and it was out of order for a few hours. During that time a rise in the ground water level of 2 m was recorded on the East side which caused the wall to deflect further. Inclinometers VI-03 and VI-05 recorded an increase of deflection of approximately 19 mm and 16 mm respectively as the water level reduced to the previous level after almost 24 hours. Refer to Figure 4 and Figure 5.

Figure 4: Inclinometer VI-03 data showing D-wall movement on May 1, 2018.

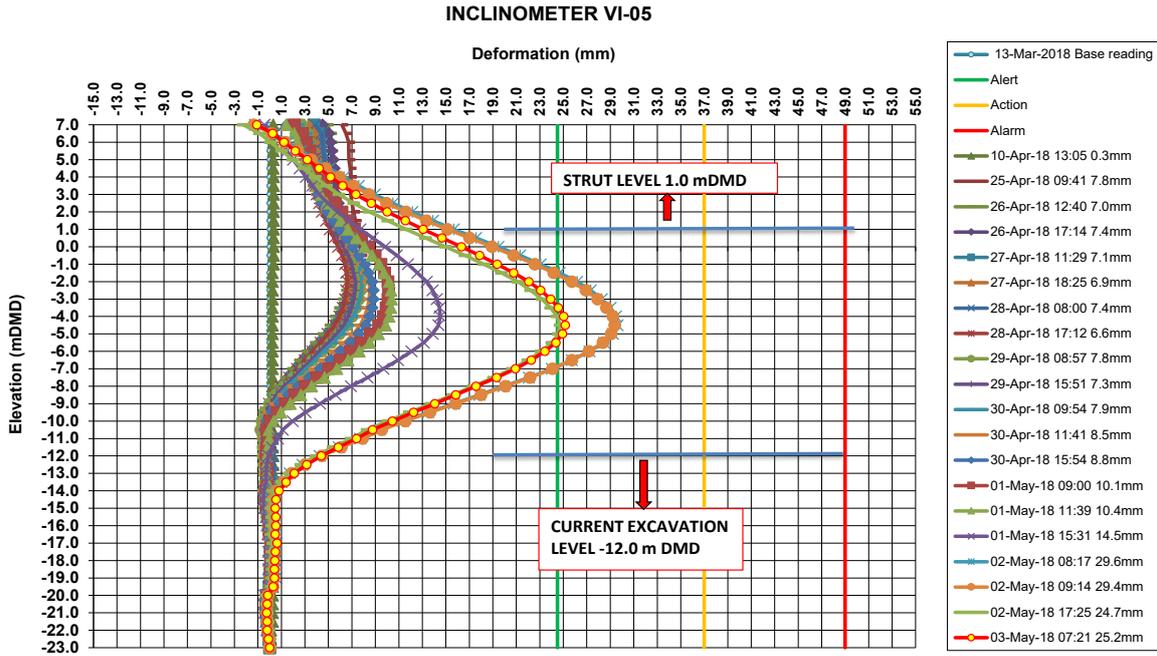
Figure 5: Inclinometer VI-05 data showing D-wall movement on May 1, 2018.

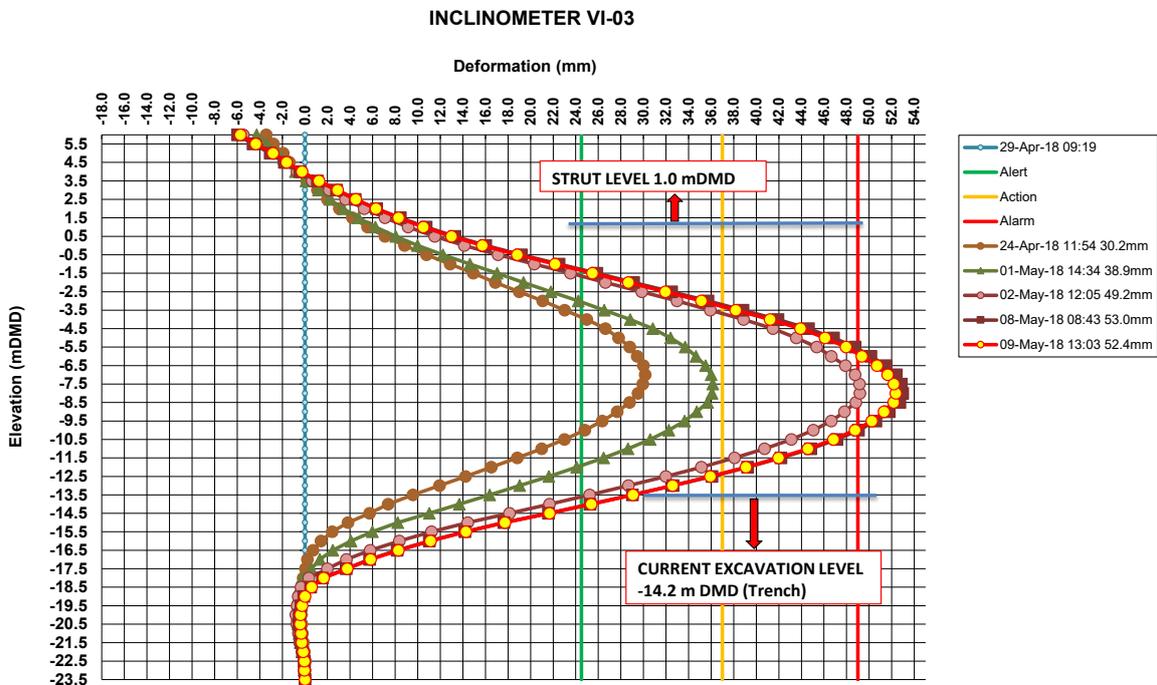
The inclinometer data of VI-03 showed a deflection of 4 mm and inclinometer VI-05 showed a deflection of almost 14 mm as can be seen in Figure 6 & Figure 7 respectively.

Figure 6: Inclinometer VI-03 data showing d-wall movement on May 8, 2018.

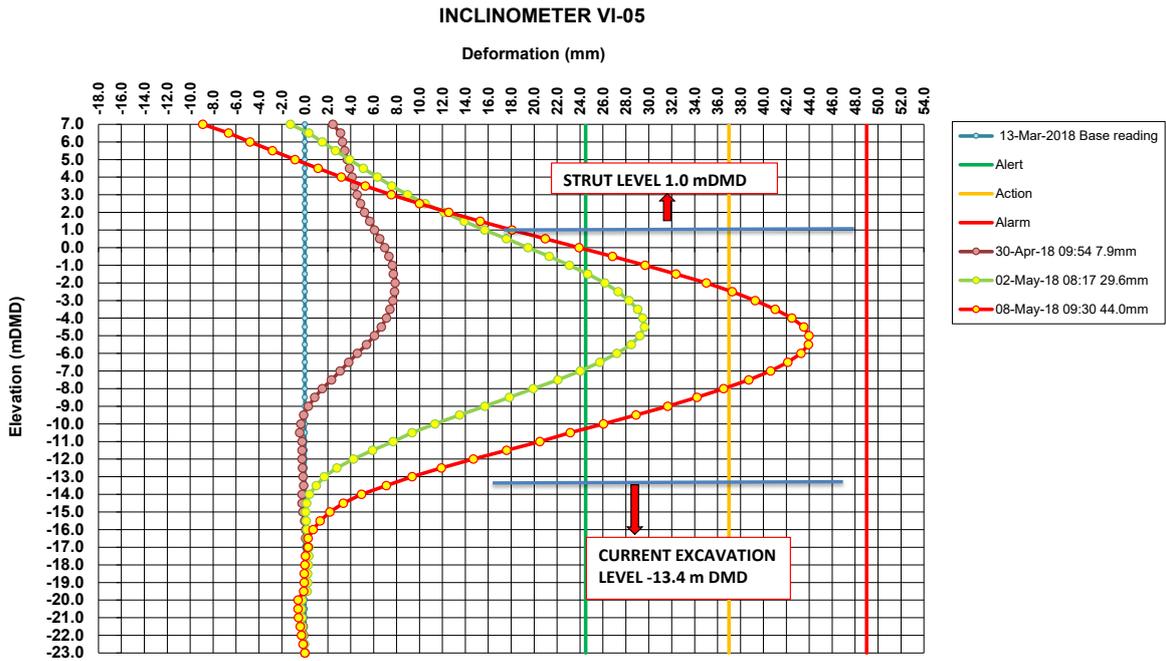
Figure 7: Inclinometer VI-05 data showing an increase in D-wall movement on May 8, 2018.

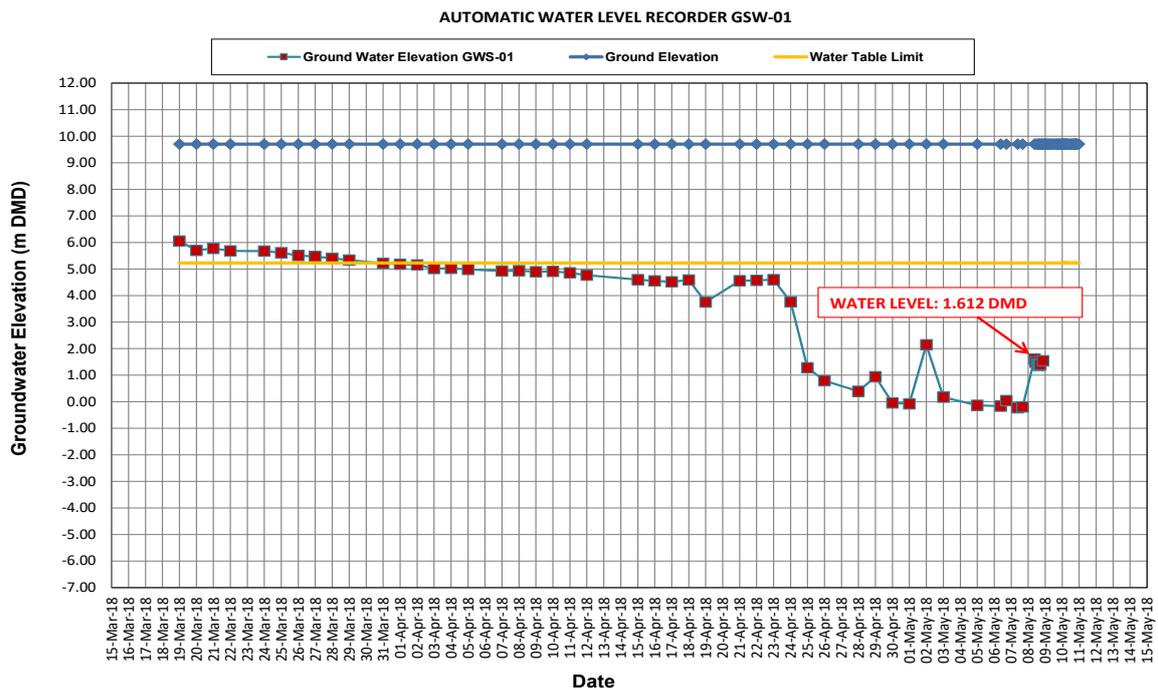
On May 8, 2018, morning, the dewatering well ADW# 14 on the East side got damaged and the repair lasted for approximately one hour. During this period the water level raised by almost 1.5 m as shown in water level data from the automatic water level recorder GWS-01 in Figure 8.

Figure 8: Water level data from automatic water level recorder GSW-01.

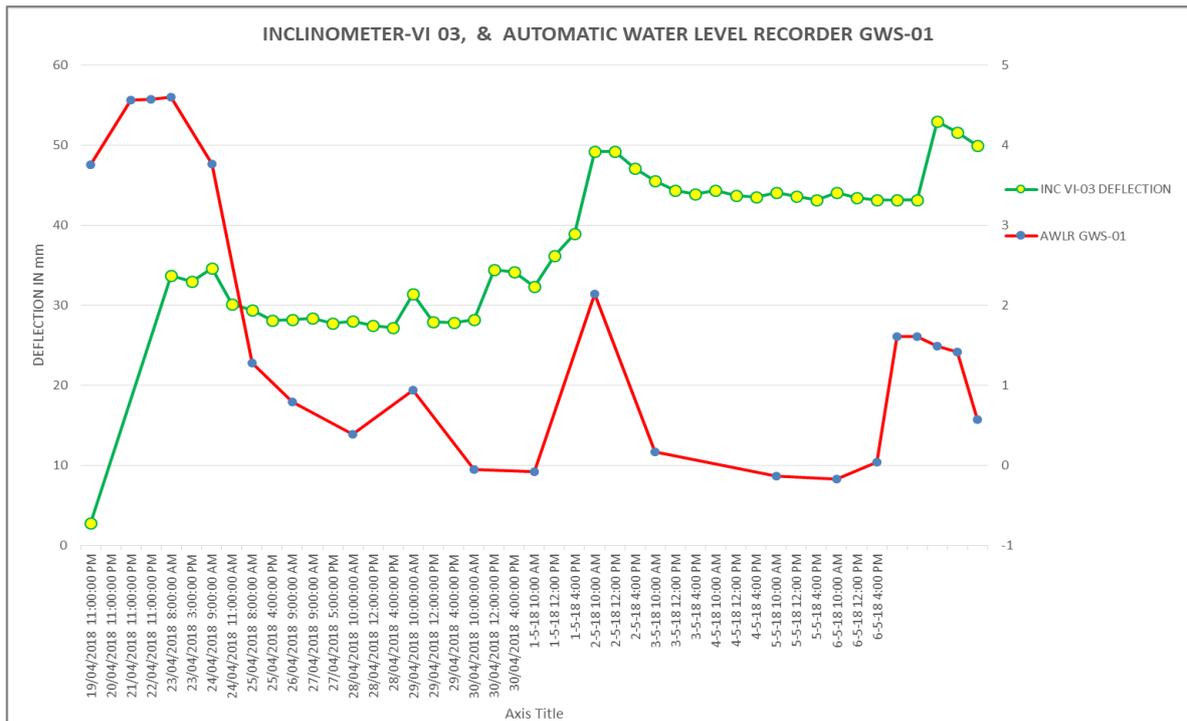
In Figure 9 below, a combined chart is plotted for data from inclinometer VI-03 and automatic water level recorder GWS-01. It shows that the diagram wall movement increases as the water level rises, although with a time lag. It also decreases as the water level decreases.

Figure 9: Combined chart for data from inclinometer VI-03 and water level data from automatic water level recorder GSW-01.

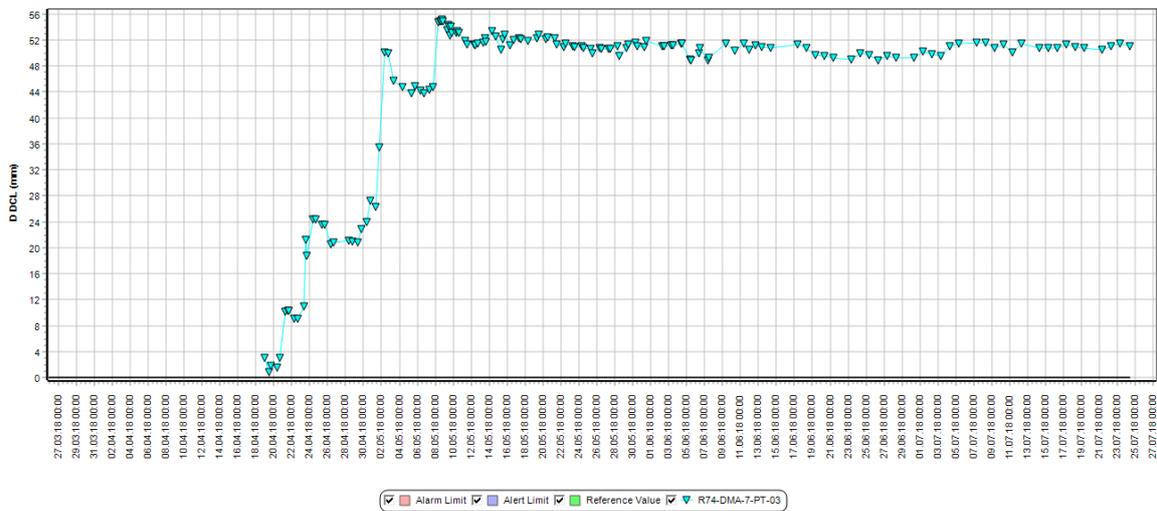
The data recorded from the prism targets, installed in close vicinity of VI-03 & VI-05, also showed the movement of the diaphragm wall on May 1, 2018, and May 8, 2018, as shown in Figure 10.

Figure 10: Prism target data showing movement on May 1, 2018, and May 8, 2018.

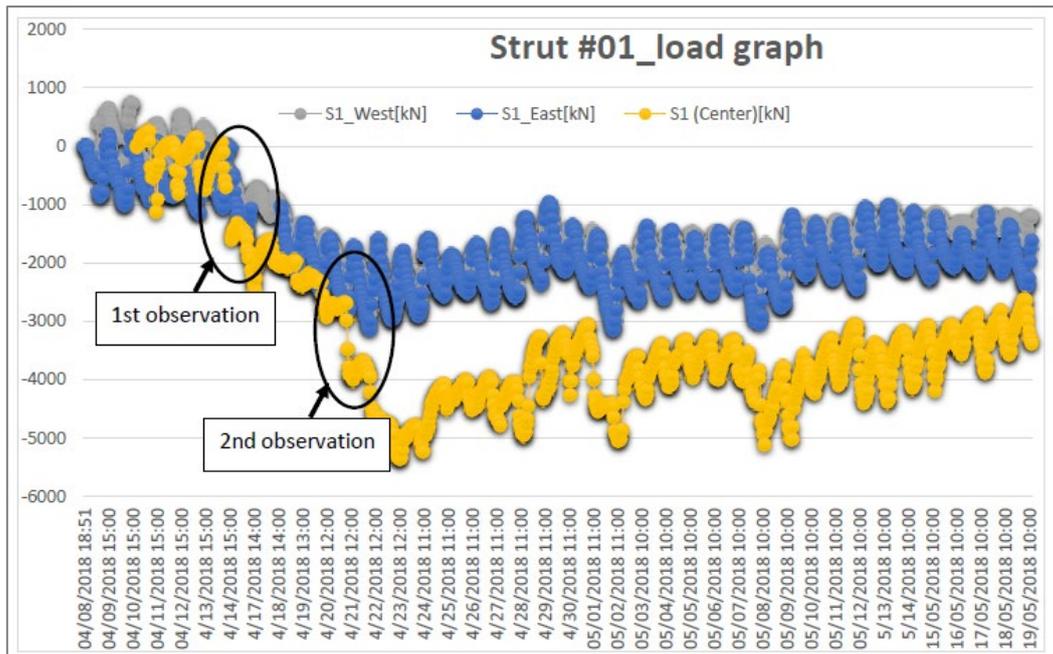
Strain gages installed on struct STR-1, supporting the East and West diaphragm walls, showed an increase in load on the same dates when inclinometer readings observed deflection with the rise in water levels. The strain gage data from strut STR-1 is shown below in Figure 11.

In the strain gage data, a high-velocity change in the strain values was also observed from 13th until 23rd April 2018. According to the daily site report, the mentioned velocity reflected the excavation activity.

Figure 11: Data from strain gages installed on strut # 1, showing an increase in load.

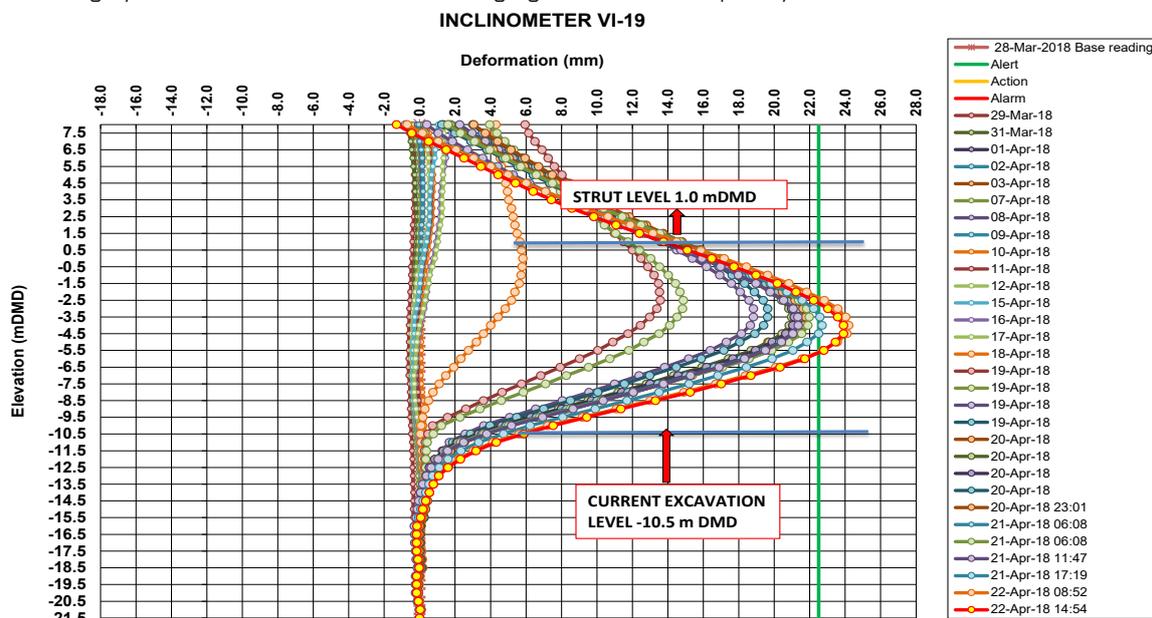
April 19, 2018, onwards the inclinometer VI-19 installed at the North headwall, started to show a rapid deflection while the excavation was at -9 m DMD. Refer to Figure 2 for the location of inclinometer VI-19 and Figure 12 for the data showing the movement.

During the site inspection, it was found that the dewatering well was not constructed on this side of the diaphragm wall. After studying the inclinometer data, the civil contractor decided to construct and install the dewatering system behind the North wall on an urgent basis. The readings reached up to 25 mm before the dewatering system was functional. The readings got stable subsequently.

Figure 12: Inclinometer VI-19 data showing D-wall movement on April 19, 2018.

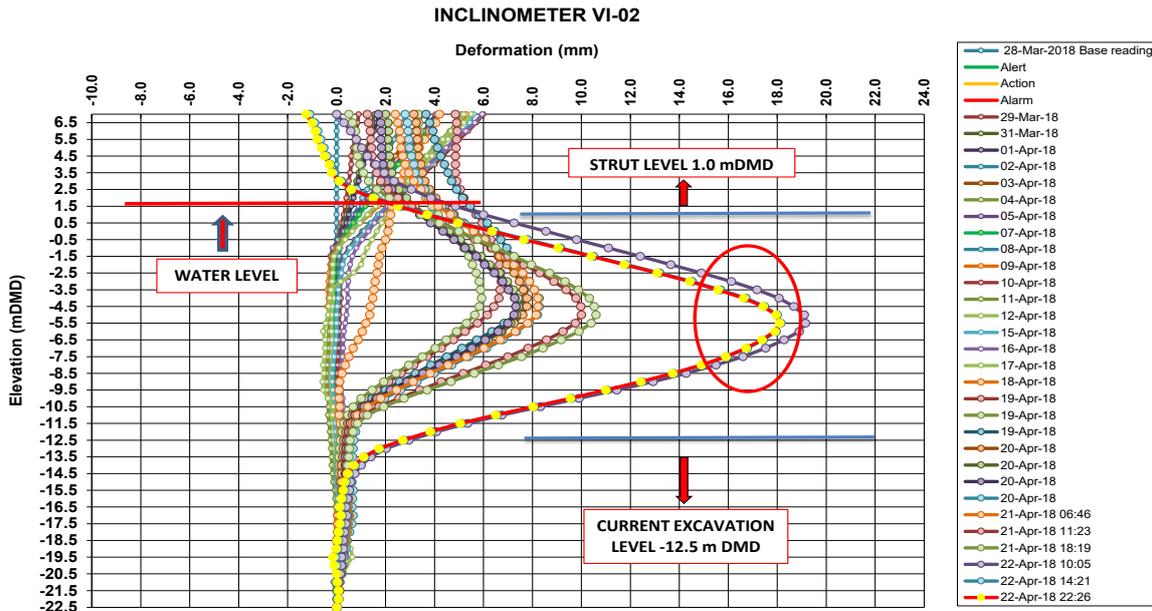
On April 22, 2018, during the excavation works on the West side of the station, a sudden increase in movements was observed in inclinometer VI-02 i.e. from 10.5 mm to 19 mm approximately due to the high water level on the West side of the station area. Refer to the data shown in Figure 13.

Figure 13: Inclinometer VI-02 data showing d-wall movement on April 22, 2018.

Looking at the readings of inclinometer VI-02 which observed a good amount of deflection in D-wall, the consultant and contractor concluded that this was occurring due to an increase in water pressure in the region. They thus decided to drill one dewatering well close to the inclinometer VI-02 location, to reduce the load (water pressure) at that location. Once the dewatering well became functional, the readings of inclinometer VI-02 stabilized.

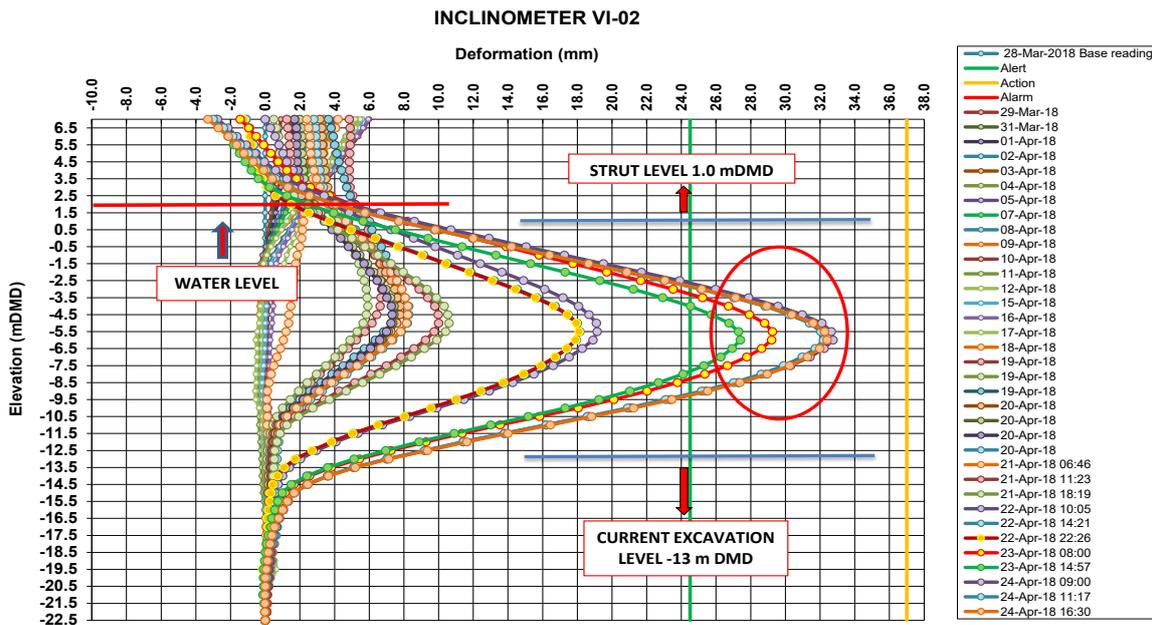
The next day, on April 23, 2018, up to 29.3 mm movement was recorded from inclinometer VI-02. Refer to inclinometer VI-02 data shown in Figure 14 below.

Figure 14: Inclinometer VI-02 data showing d-wall movement on April 28, 2018.
