**MARCH 2010**

### INSTRUMENTATION OF SEGMENTAL LINING FOR A MACHINE BORED TUNNEL

## EXCESSIVE GROUT INJECTION PRESSURE DETECTED BY INCLINOMETER

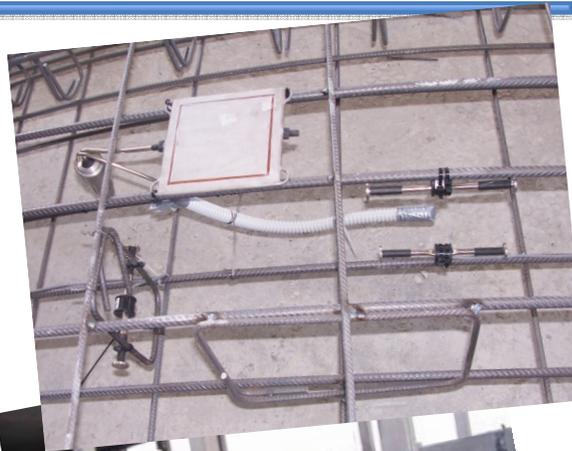
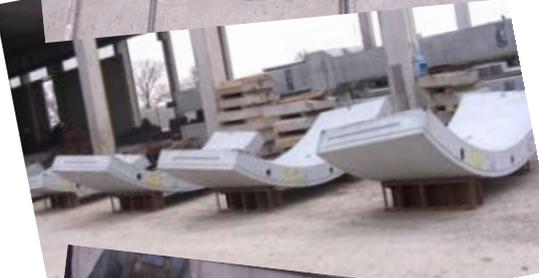
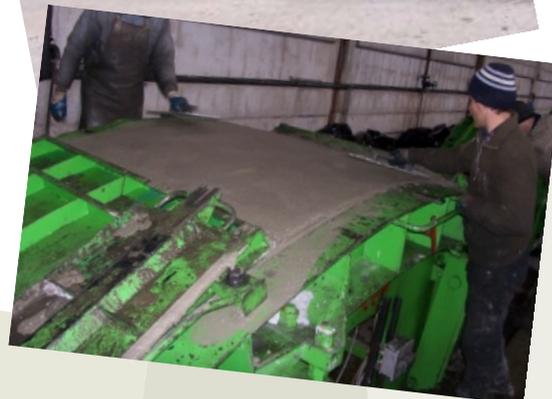
Method of tunnel construction involves excavation by TBM and simultaneous erection of segmental concrete lining that provides both support and a final lining. The concrete segments are earlier cast and then transported to site. Easy way of instrumenting the segments during concreting is illustrated in the three adjoining pictures. Top picture shows mounting of an Encardio-rite concrete pressure cell and a few Encardio-rite embedment strain gages in different axis before concreting. The bottom picture shows the segment being completed. These pictures are courtesy our Marketing Associate GD Test Srl in Italy who used the instrumentation for online monitoring of the stresses in the segments.

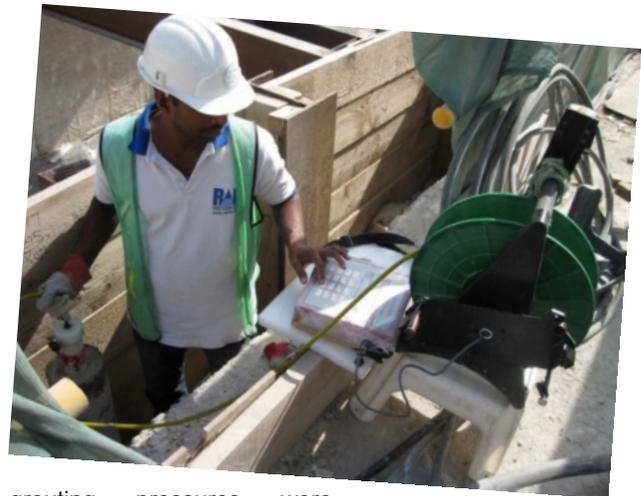
Data analysis of inclinometer results, which showed excessive deformations at an increasing rate at around 15 m from the installation's top, revealed that the grouting pressure was the culprit!

was carried out in the TBM launch area adjacent to a TBM launch shaft, for ground improvement purpose. The deformation with respect to the base readings - which were established long before the activities started, increased towards the excavated area as the grouting proceeded.

Seeing the above deformation (mm) v/s depth (m) results, in which the deformations approached the alert level of 17 mm set by the project designers,

grouting pressures were moderated not only for the above site but also for the future ground improvement works in other areas of the project.

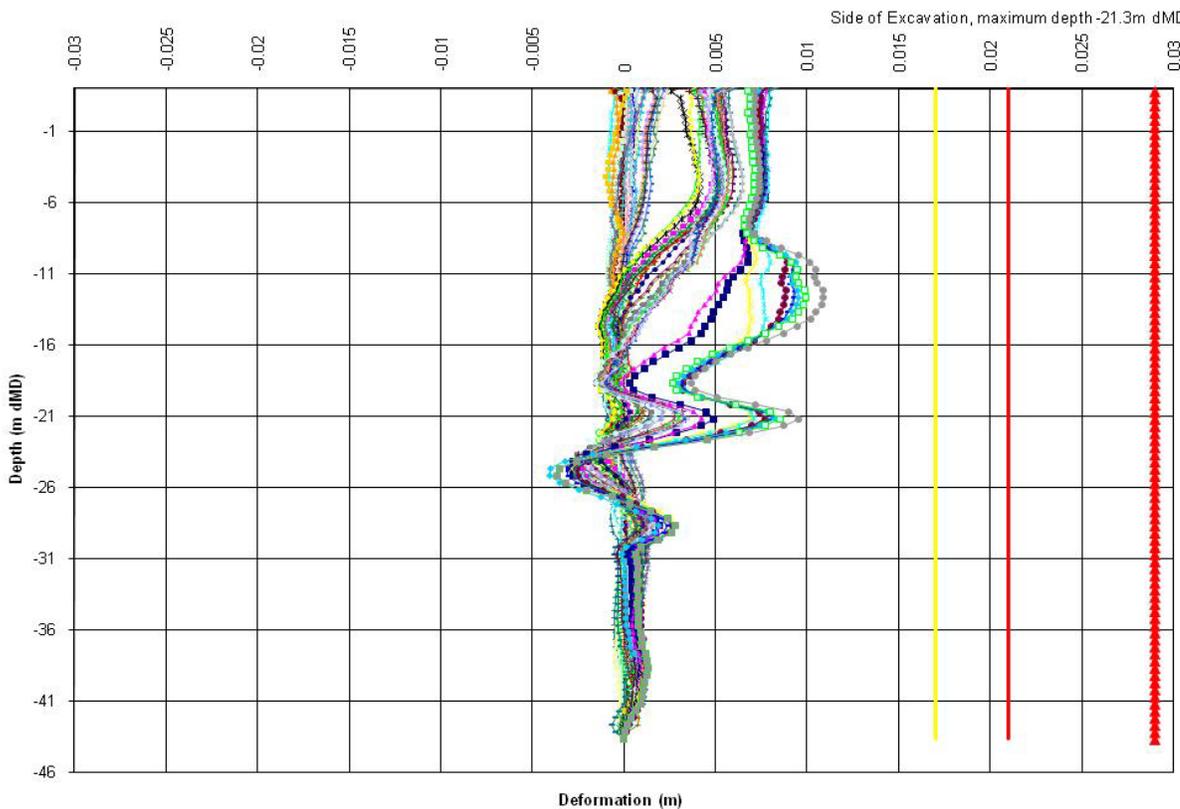
Inclinometer in diaphragm wall
