AUGUST 2010

Chairman's Note

INSTRUMENTATION AND MONITORING OF MIRANI FORT, OMAN

VIBRATING WIRE PIEZOMETERS INSTALLATION AT MULTILEVELS USING THE FULLY GROUTED METHOD

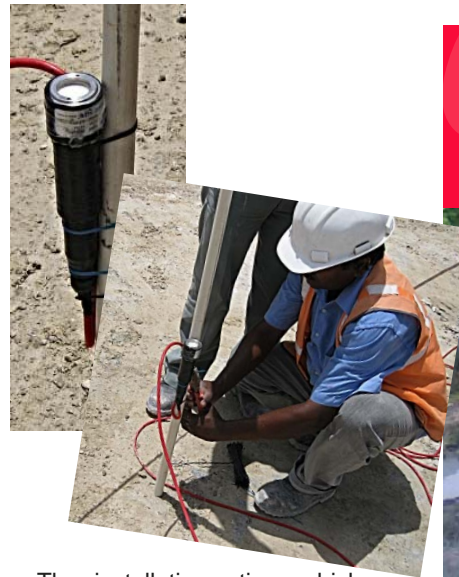
and lowered down the borehole. Tip of sensors were pointed upwards to avoid escape of deaired water filled between the ceramic filter and the sensing diaphragm. Cables from the piezometers were secured to the pipe itself. The borehole was fully grouted from the bottom, using the same 20 mm PVC pipe, with cement bentonite grout. Ratio of cement, bentonite and water used was 1:0.3:2.5 by weight. Readings from piezometers at various levels in one of the boreholes are shown in the graph below.

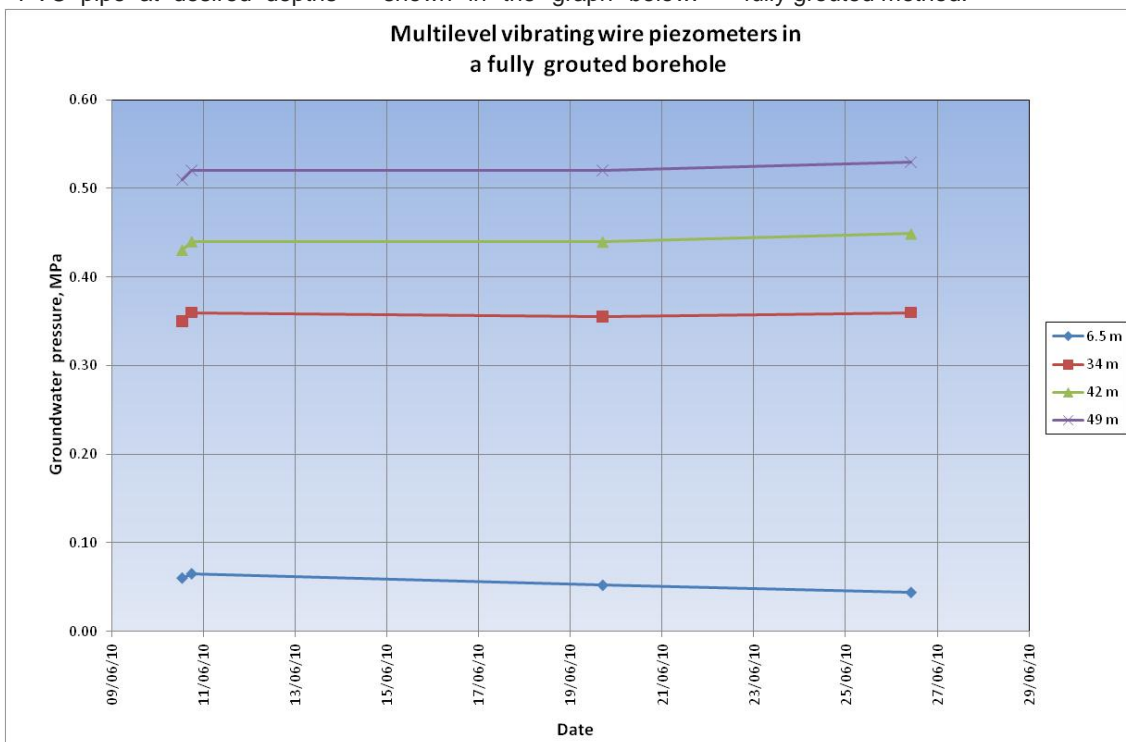
Multilevel vibrating wire piezometers in a fully grouted borehole

Encardo-rite EPP-30V VW piezometer were attached to the outer surface of a 20 mm PVC pipe at desired depths

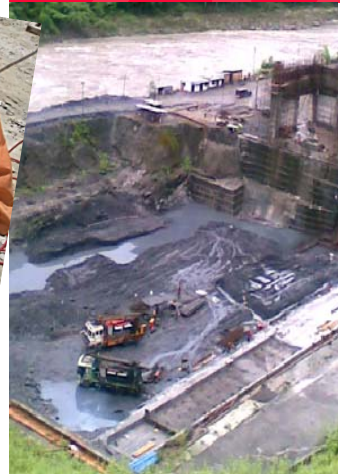
KIMI semi underground power house of Kameng (NEEPCO) is being constructed on an unstable slope. Protection measures are being taken to prevent slope failure. To monitor slope stability, inclinometers were installed at 19 locations in different benches. The maximum movement recorded by the inclinometers was up to 150 mm.

Due to land movement, cracks also developed in benches. The cracks directions were co-relating with inclinometer data. Inclinometers gave very good data to take corrective actions for the stability of the slope.

Piezometers were also installed to monitor the hydrostatic pressure being developed in slope.
