Utilization of Instrumentation Data for Averting a Potential Support Failure in a Deep Excavation Project

Arushi BHALLA¹, Prateek MEHROTRA²

Keywords: deep excavation, deformation monitoring, risk mitigation

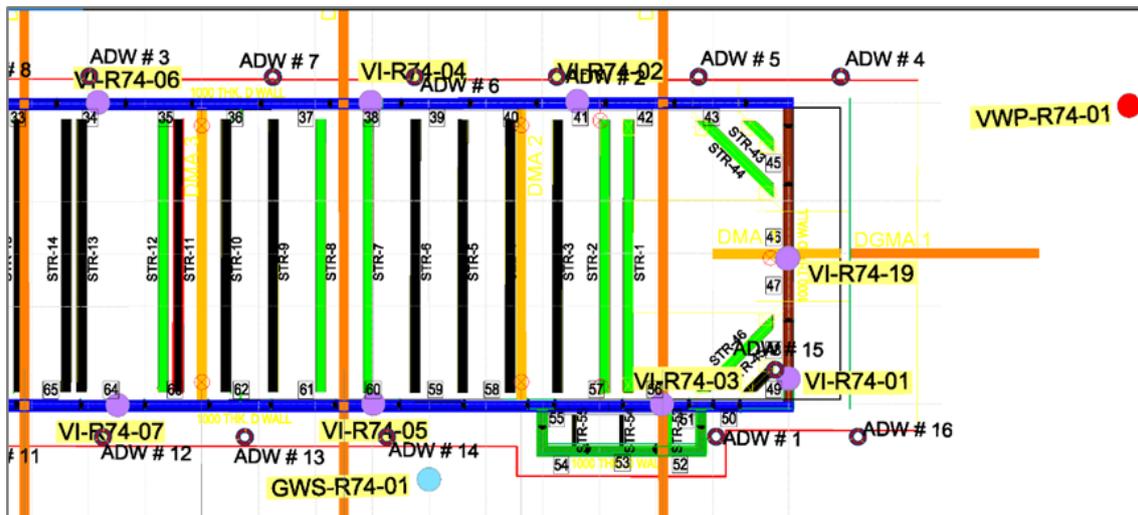
Figure 2: Close up view of instrument layout for East side diaphragm wall, showing inclinometers VI-03, VI-05 (incidence 1), VI-19 (incidence 2), VI-02 (incidence 3); dewatering well ADW # 01; water standpipe GSW-01 (automated later); Strut STR-1 with strain gages.

On May 1, 2018, the dewatering well ADW # 01 (location shown in Figure 2 above) was damaged by the nearby works and it was out of order for a few hours. During that time a rise in the ground water level of 2 m was recorded on the East side which caused the wall to deflect further. Inclinometers VI-03 and VI-05 recorded an increase of deflection of approximately 19 mm and 16 mm respectively as the water level reduced to the previous level after almost 24 hours. Refer to Figure 4 and Figure 5.

On May 8, 2018, morning, the dewatering well ADW# 14 on the East side got damaged and the repair lasted for approximately one hour. During this period the water level raised by almost 1.5 m as shown in water level data from the automatic water level recorder GWS-01 in Figure 8.

April 19, 2018, onwards the inclinometer VI-19 installed at the North headwall, started to show a rapid deflection while the excavation was at -9 m DMD. Refer to Figure 2 for the location of inclinometer VI-19 and Figure 12 for the data showing the movement.

On April 22, 2018, during the excavation works on the West side of the station, a sudden increase in movements was observed in inclinometer VI-02 i.e. from 10.5 mm to 19 mm approximately due to the high water level on the West side of the station area. Refer to the data shown in Figure 13.

During the site inspection, it was found that the dewatering well was not constructed on this side of the diaphragm wall. After studying the inclinometer data, the civil contractor decided to construct and install the dewatering system behind the North wall on an urgent basis. The readings reached up to 25 mm before the dewatering system was functional. The readings got stable subsequently.

Looking at the readings of inclinometer VI-02 which observed a good amount of deflection in D-wall, the consultant and contractor concluded that this was occurring due to an increase in water pressure in the region. They thus decided to drill one dewatering well close to the inclinometer VI-02 location, to reduce the load (water pressure) at that location. Once the dewatering well became functional, the readings of inclinometer VI-02 stabilized.
